RedMax®

TECHNICAL SERVICE BULLETIN
T09 - 02

To: All RedMax Distributors and Dealers
Subject: GZ3500T Carburetor

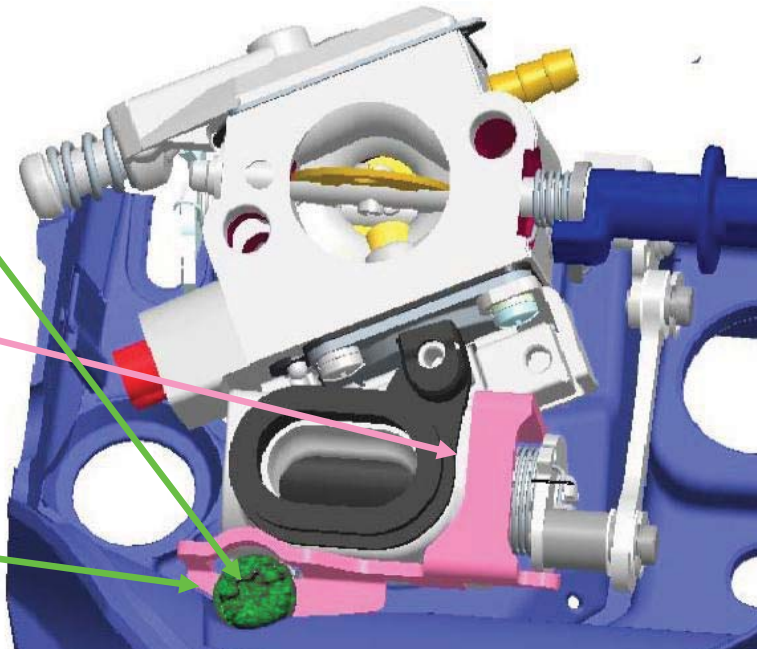
Problem:The Air Valve could become misaligned at idle preventing advancement of the throttle.

Solution: Install alignment bracket on the air valve. This bracket will keep the Air Valve linkage aligned with the Throttle Valve linkage when the Throttle lever is depressed.

1. Remove the Air Box Cover, and Air Filter
2. Remove Screw from Carburetor
3. Lay Bracket into place as shown

4. Reinstall screw and tighten securely
5. Reinstall the Air Box Cover, and Air Filter
